Date: October 14, 2014 **Meeting Date:** October 21, 2014
Subject: Pedestrian Crossing Study – Bush Street and Heinlen Street.

PEDESTRIAN CROSSING STUDY

**BUSH STREET
AT
HEINLEN STREET**

LEMOORE, CALIFORNIA

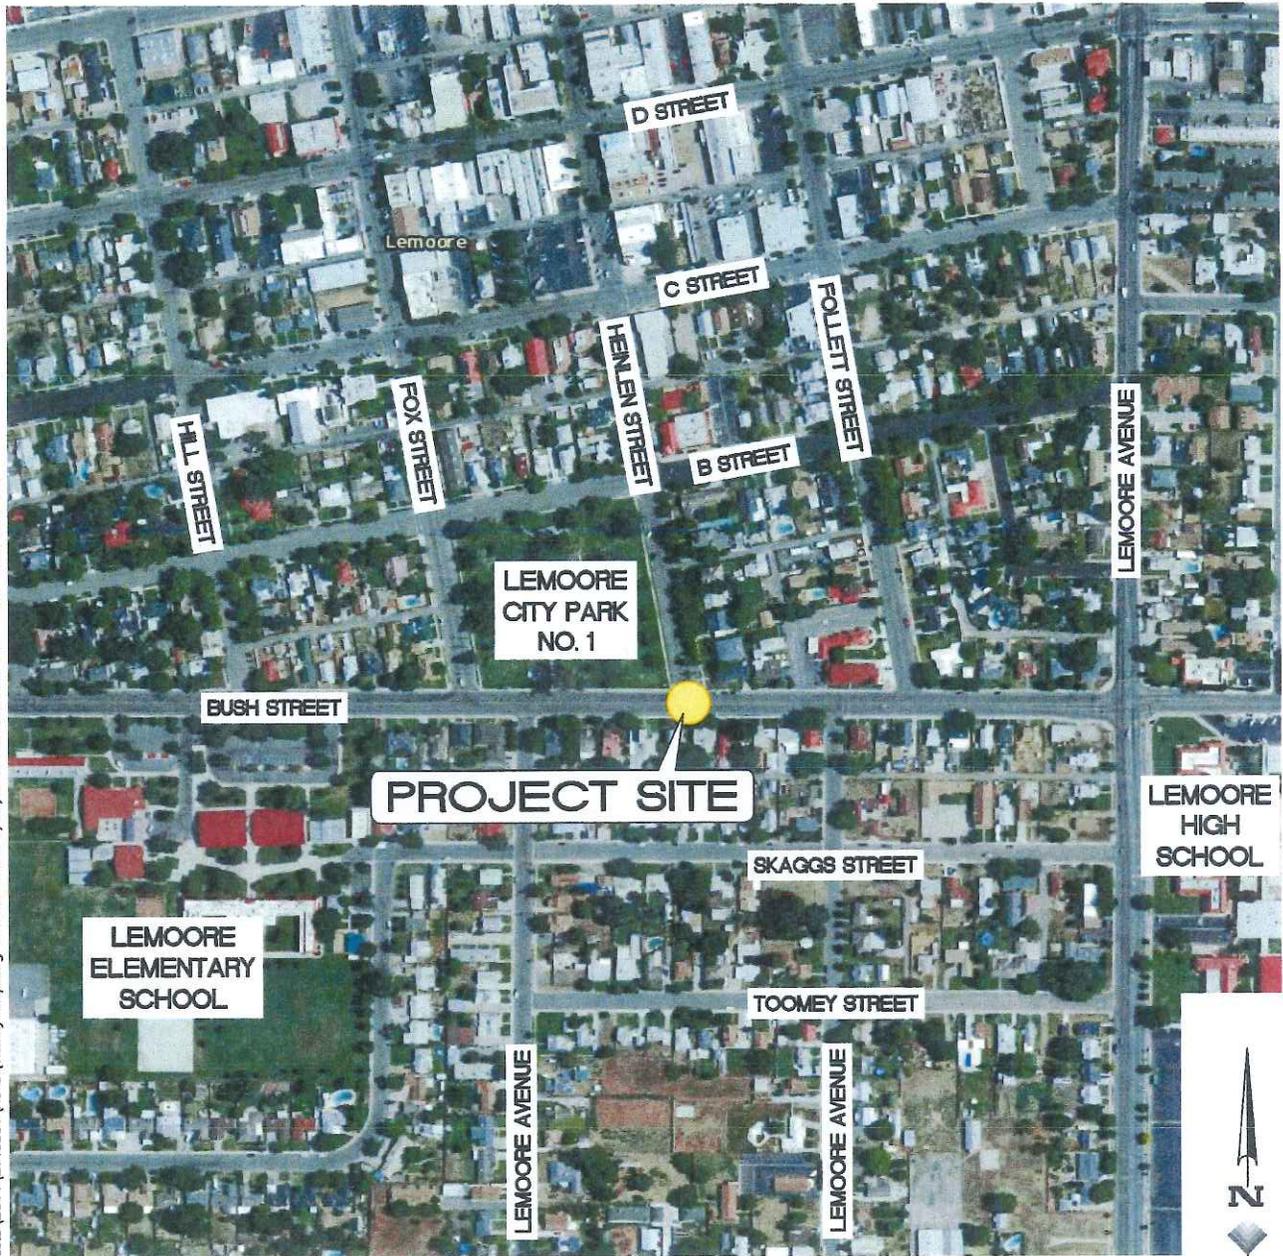
CITY OF LEMOORE
FIGURE 1 - VICINITY MAP
BUSH STREET
AT
HEINLEN STREET

This report has been prepared to present the results of a pedestrian crossing study, conducted by Quad Knopf, for a proposed marked pedestrian crosswalk across Bush Street at Heinlen Street in the City of Lemoore (see Figure 1). Quad Knopf was hired to review the existing intersection conditions and determine if a marked crosswalk at this location is appropriate, and if so, to recommend safety enhancements and pedestrian crossing alternatives. One alternative reviewed was a potential in-roadway warning light (IRWL) system. As part of this study, Quad Knopf also completed the analysis for a potential multi-way stop at the intersection.

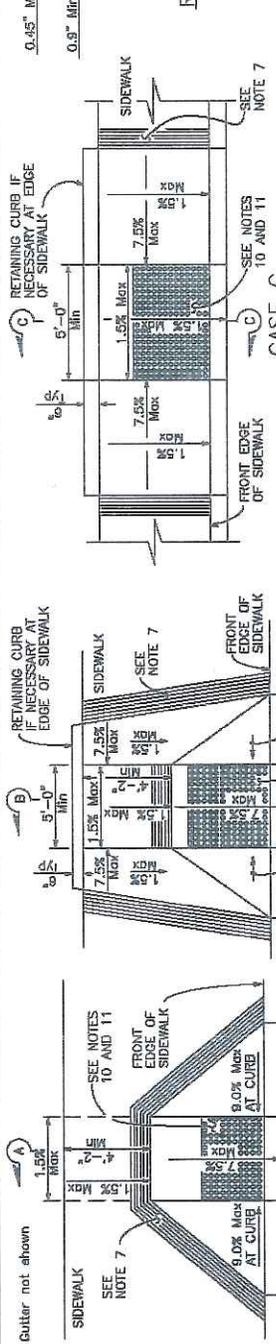
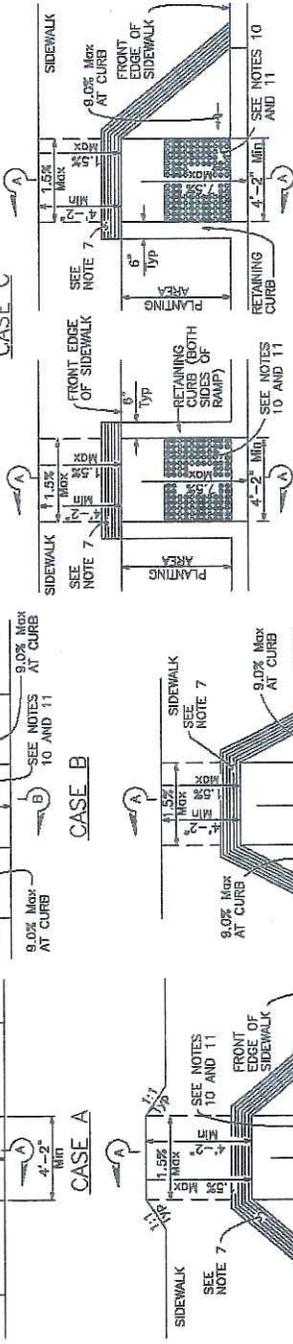
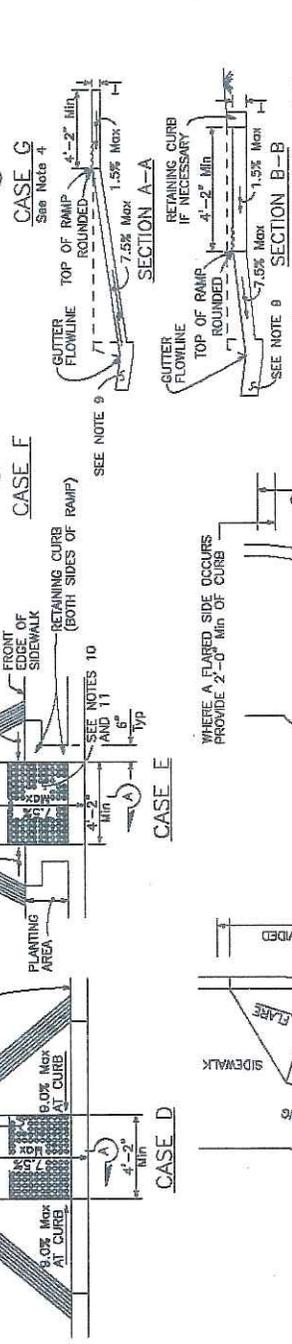
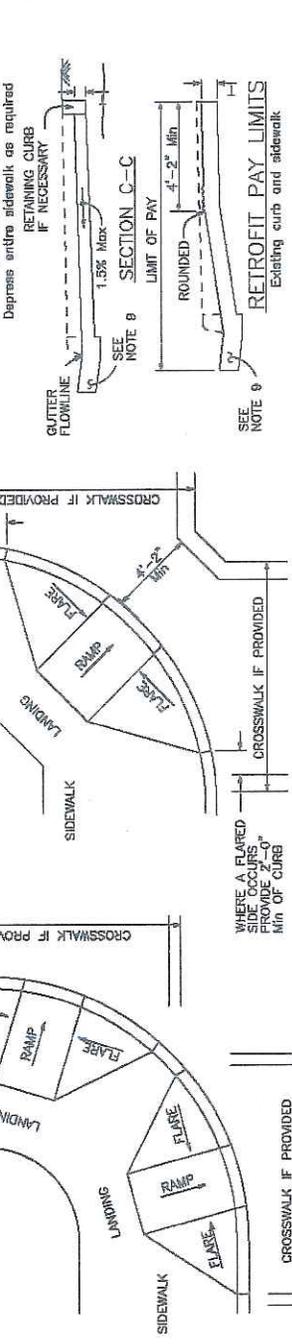
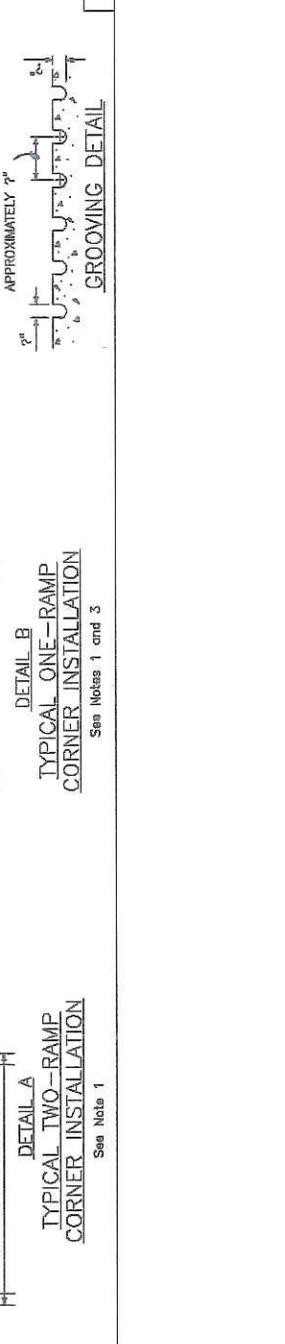
REVISED STANDARD PLAN RSP AB8A

**RAISED TRUNCATED DOME PATTERN (IN-LINE)
DETECTABLE WARNING SURFACE**

See Note 10

- a. Associated signage shall be installed.
 - b. An accessible curb ramp shall be constructed on the south side of Bush Street to comply with the current ADA requirements as indicated on the State of California Department of Transportation Standard Plan RSP A88A. A copy of said plan is included in Appendix D of this report.

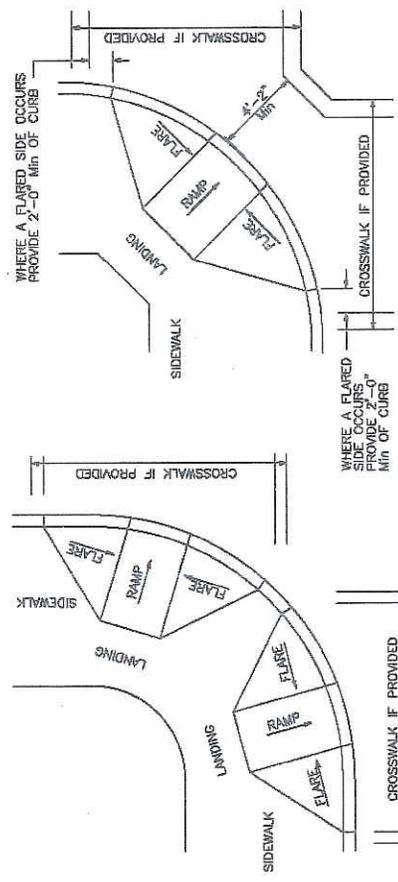
DETAIL B

TYPICAL ONE-RAMP CORNER INSTALLATION

See Notes 1 and 3

3. When ramp is located in center of curb return, crosswalk configuration must be similar to that shown for Detail B.
4. As site conditions dictate, the retaining curb aids and the flared side of the Case G ramp shall be constructed in reversed position.
